PROJECT TITLE: INVESTIGATION OF THE I88 CARRS CREEK GEOFOAM FAILURE

PRINCIPAL INVESTIGATOR(S): DR. DAWIT NEGUESSEY

INSTITUTION: SYRACUSE UNIVERSITY

COMPLETION DATE: AUGUST 2014

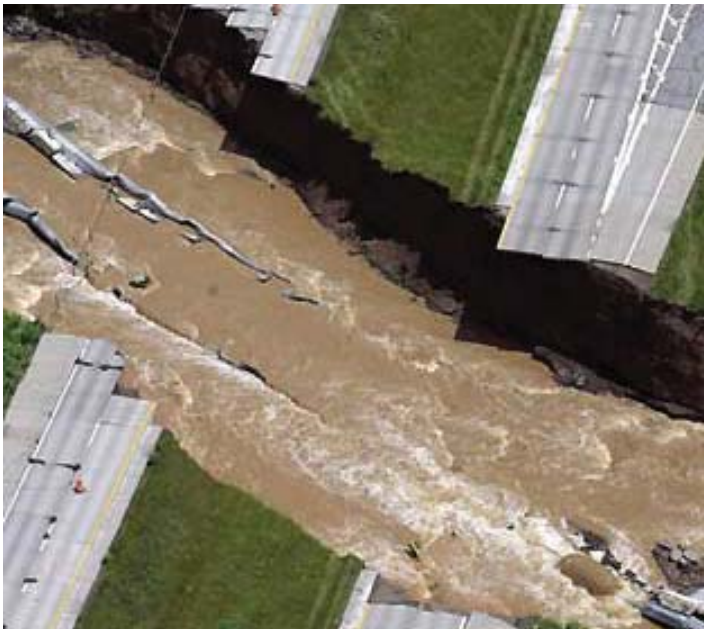
Figure 1 Aerial view of the I88 Carrs Creek culvert failure.

The Carrs Creek culvert collapsed during the Mid- Atlantic States Flood in June 2006. Rapid construction with geofoam fill enabled partial reopening of I88 by Labor Day. Soon after opening, excessive settlements developed and the geofoam was replaced with lightweight aggregates and I88

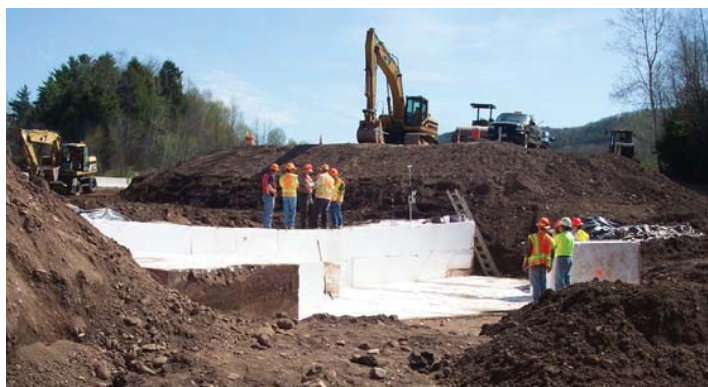
Figure 2 Excessive settlement and removal of the geofoam fill.

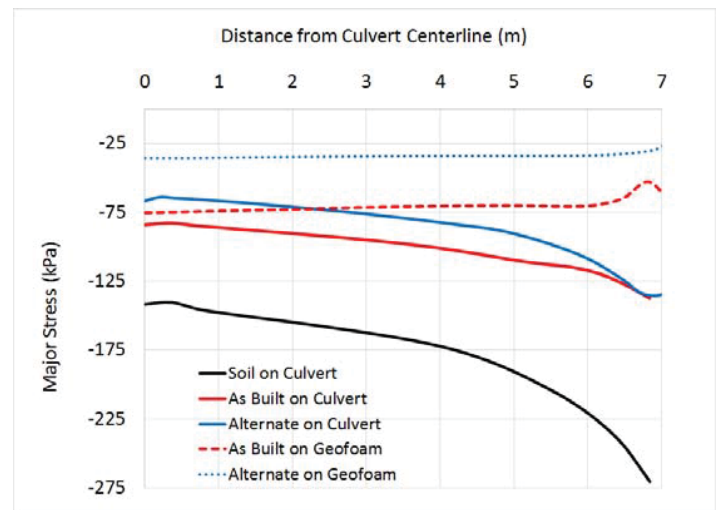
The previous investigation of the failure was reviewed. Additional tests and computer simulations were performed. Because of the relative stiffness of the culvert edge and the pile foundation, loading from the overlying soil would have been amplified by negative arching. The up to 2.7m of geofoam fill reduced the dead loads on the culvert. However, the geofoam blocks below the east and westbound roadways became overloaded and deformed excessively. Explanations for the failure that are presented in the report are different from likely causes identified in the previous investigation. Quality assurance for geofoam blocks, installation method, provision of internal drainage and considerations of creep under both confined and unconfined loading were important. The report provides suggestions for improving rapid construction with geofoam. An alternative design with reduced and uniform stress levels in the geofoam along the length of the culvert is presented.

Figure 3 Stresses on the culvert and the geofoam.
