1. Report No.	2. Government Accession No.	3. Recipient's Catalog No.	
4. Title and Subtitle  Long-term infiltration capacity of different types of permeable pavements		5. Report Date  August 2017

## **Long-term infiltration capacity of different types of permeable pavements**

Kirk R. Barrett, PhD, PE and Mohamed Diallo  
Manhattan College Department of Civil and Environmental Engineering, Riverdale, NY  
August 2017

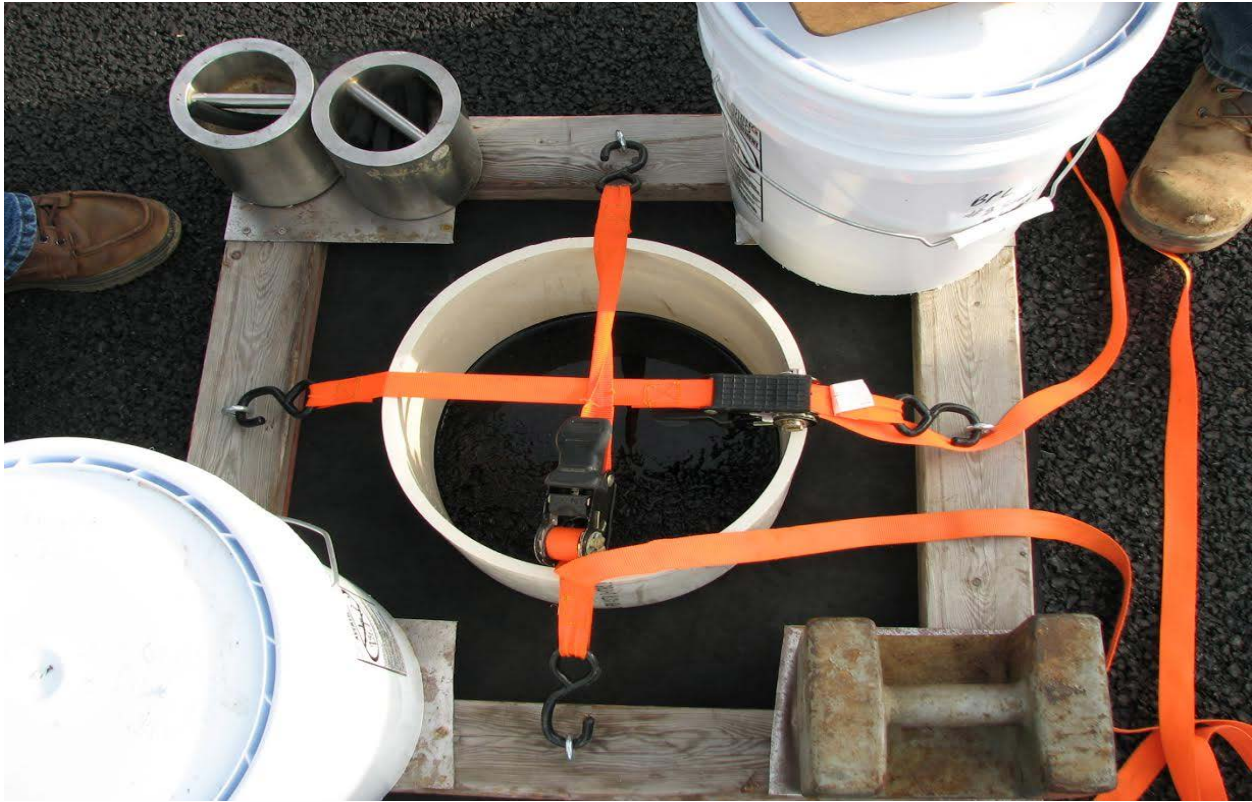
*Figure 2: Study apparatus showing the PVC pipe and Neoprene compressed with applied weights to minimize leakage. Photo provided by Thomas O'Connor of USEPA.*

Regular measurements of IC were restarted in late October 2014 after a two-year gap with the goal of testing all locations in each pavement type (see Figure 3) and continued through August 2016. The present study followed Brown and Borst's methods for monitoring IC in these pavements: a modified version of ASTM C1701 [10], which applies to measurement of IC of pervious concrete, for all three types of pavements. Briefly, the apparatus used was a 0.15 m (6 in) long section of 0.302 m (11.875 in) diameter PVC hollow cylinder (Figure 2), which was placed on the pavement. This cylinder was placed on a 12.7 mm (0.5-in) thick ring of Neoprene to form a seal with the pavement. To minimize leakage, the PVC pipe was pressed tightly against the pavement by applying weight at the corners of a wooden panel fitted with two fastening belts running over the top of the PVC cylinder. Additional strips of Neoprene were placed in the gap between individual pavers under the PVC cylinder when testing the PICP pavement.

After positioning the PVC cylinder at a test spot for infiltration rate measurement, a pre-wet test was first performed. A bucket was filled with 3.6 kg of water. Water was poured from the bucket into the cylinder, maintaining the water level between 10.0 and 15.0 mm (0.4 and 0.6 in) above the pavement surface, over a maximum pre-wet test time of 30 minutes. If the entire 3.6 kg of water (equivalent to 50 mm or 2 in. depth) was applied, the time from when the water first impacted the permeable pavement surface to when water was no longer visible on the surface was measured with a stopwatch and recorded as the "pre-wet time". If the test lasted the entire 30 minutes without infiltrating the entire 3.6 kg (which infrequently), the mass of water that infiltrated during the 30 minutes was computed by subtracting the mass of water remaining in the cylinder and in the bucket from 3.6 kg.

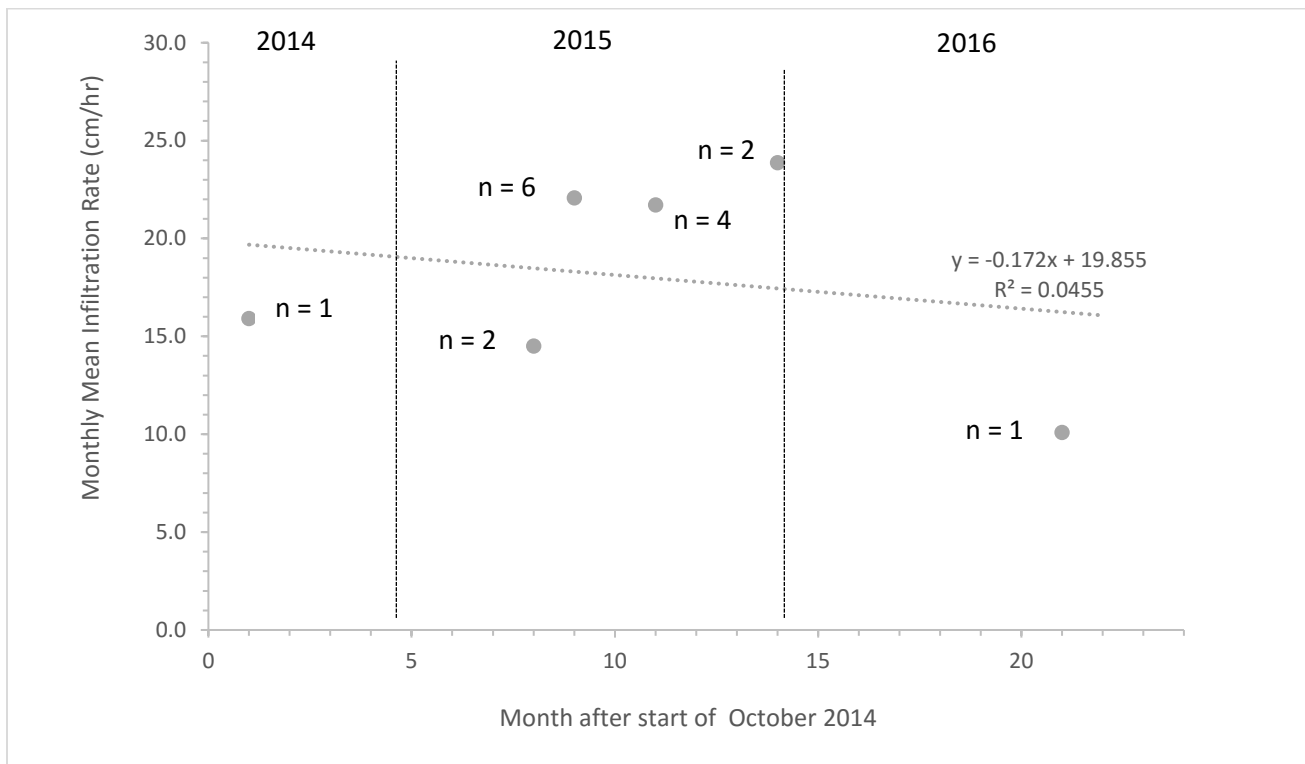
Figure 4: Linear regression of mean monthly infiltration capacity for PA on the interior testing locations with the number of monthly samples (n)

Because there were relatively few edge locations (Table 2) and there was a significant difference between mean IC of edge and interior locations, the analysis of time variance in IC was applied to interior locations only. A linear regression was performed between months since the beginning of monitoring and the mean monthly IC for each of the three pavement types in consideration, as shown in Figures 5-7 with the results summarized in Table 3.

All three pavement types showed a declining trend in IC with time, but the correlation was weak in all cases, with all p-value  $\geq 0.15$  and all  $R^2$  values  $\leq 0.36$ . Furthermore, none of the pavement types showed consistently decreasing trends, with both increases and decreases occurring from monitoring event to the next.

The slope of the regression line (measured in cm/hr/month) was lowest (by nearly 100x) for PA. This can be partially explained by the fact that the observed IC is much less for PA, so it will naturally change by less. PICP showed the sharpest decline (slope of -54 cm/hr/month), with the regression line headed toward an IC of 0 at ~25 months (Fig. 6), but with a low  $R^2$  value, the regression line is not a reliable predictor.

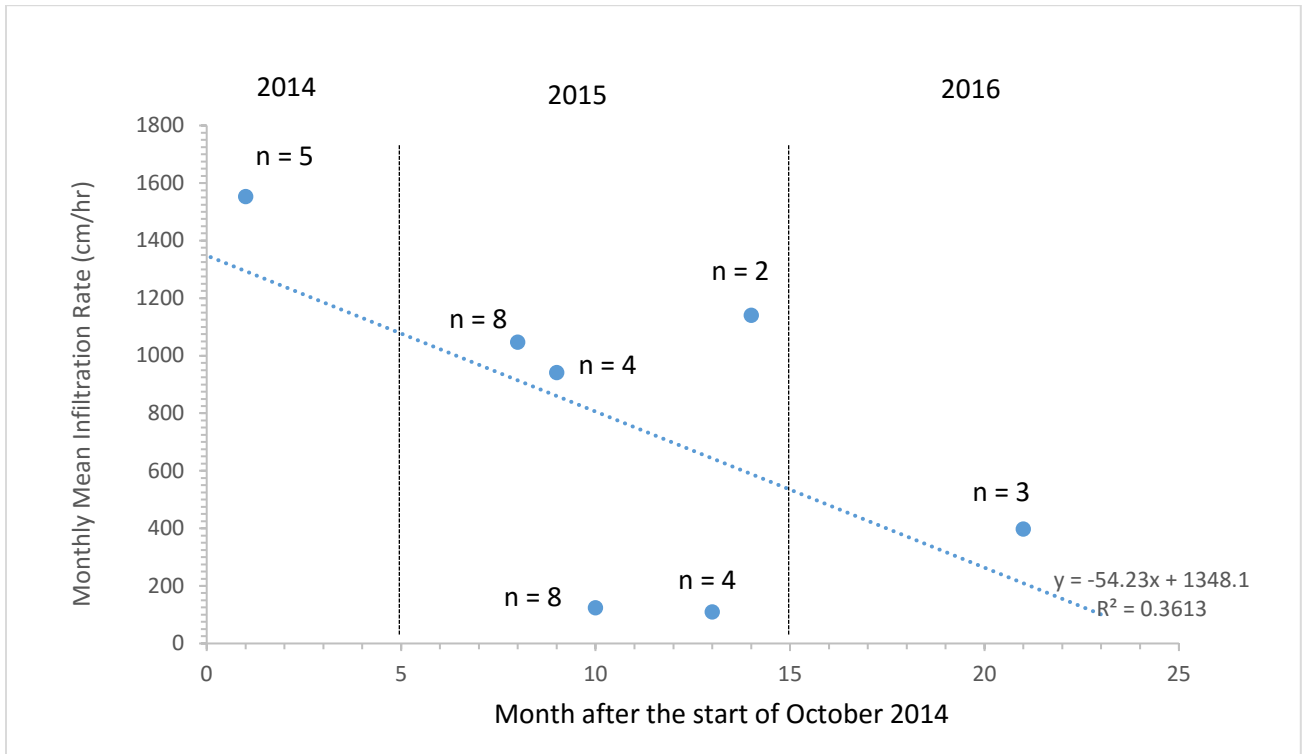
Figure 6: Linear regression of mean monthly infiltration capacity for PICP on the interior testing locations with number of monthly samples (n)
