Final Report

Consistency of the New York State Bridge Inspection Program

Performing Organization: City University of New York

September 2013

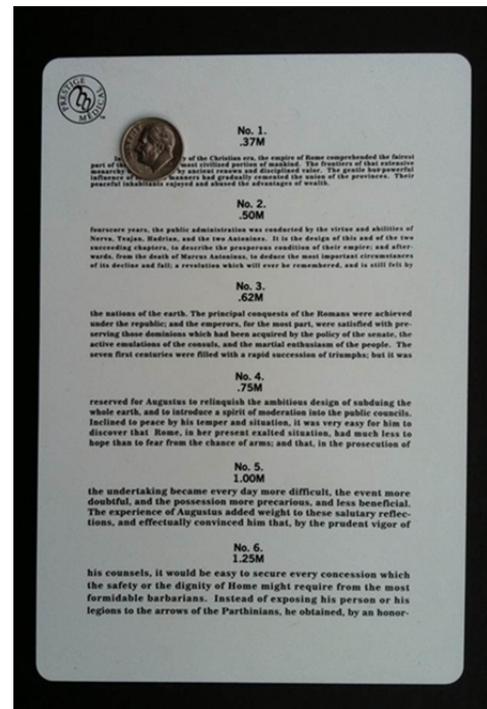
Figure 1-6: Photograph of Jaeger Visual Acuity Test Card.

Visual acuity testing has not been a requirement for bridge inspectors, though a few states require driving certifications that include vision test [Moore et al. (2001)]. In other industries, a simple, on-site visual acuity test is utilized to ensure that inspectors meet a minimum vision standard [Kleven and Hyvarinen (1999)]. This simple-to-implement eye test requires only that an inspector read some lines of the text printed on a card, as shown in Figure 1-6, at a distance of 12 to 14 inches. Typical requirements are to read the J2 line of text, which provides an equivalent of 20/20 near-distance acuity. Test can be conducted annually, simply to ensure that the inspector has vision corrections, if needed. A Jaeger eye test can be completed on-site in less than 1 minute. A laminated Jaeger card costs approximately \$7.50.

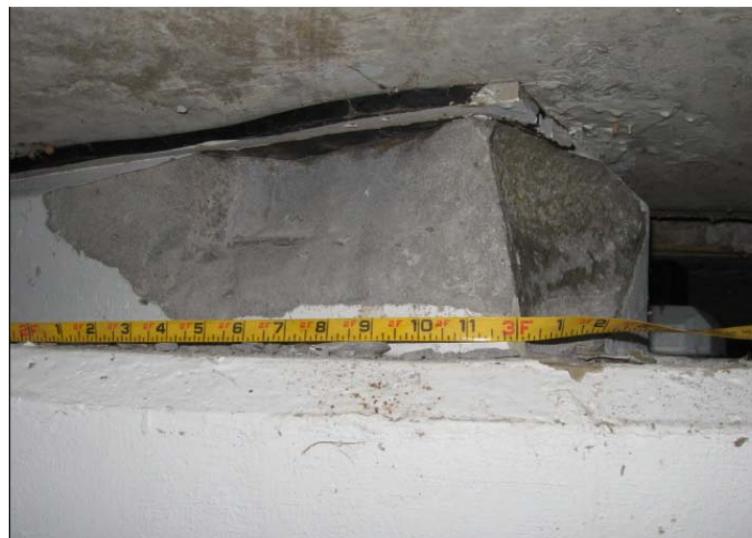
Figure 3-6: Spalled Portion of the Pedestal 12 at the Pier 2 in the Bridge 1026170.

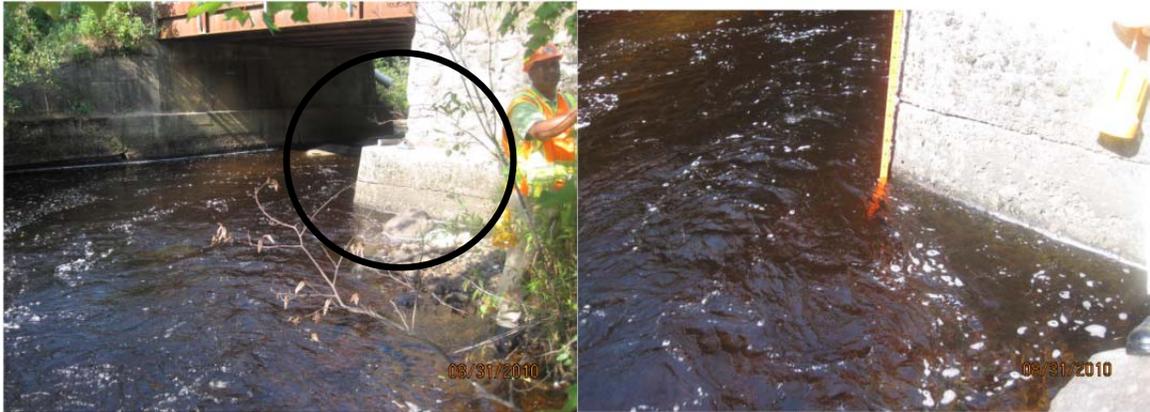
Figure 3-7: Photographs Showing Substructures of Bridge 2205690 Protruding into the Channel.

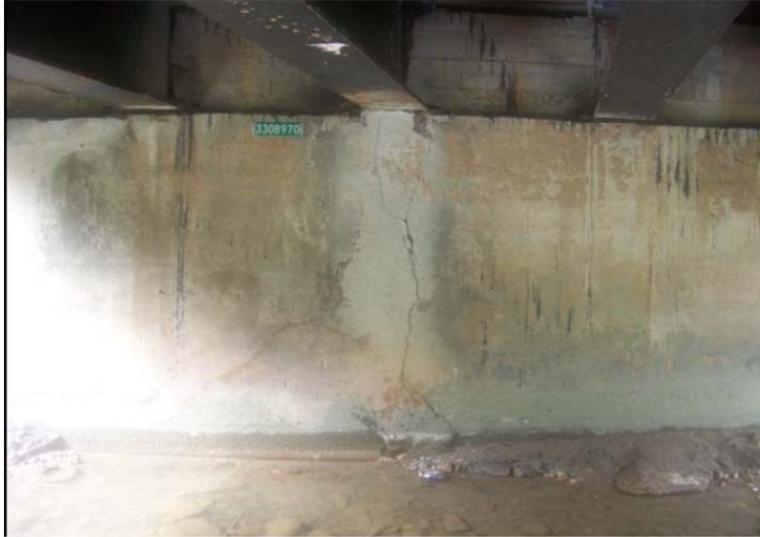
Figure 3-9: Photographs Showing Cracks in the Begin Stem of the Bridge 3308970.

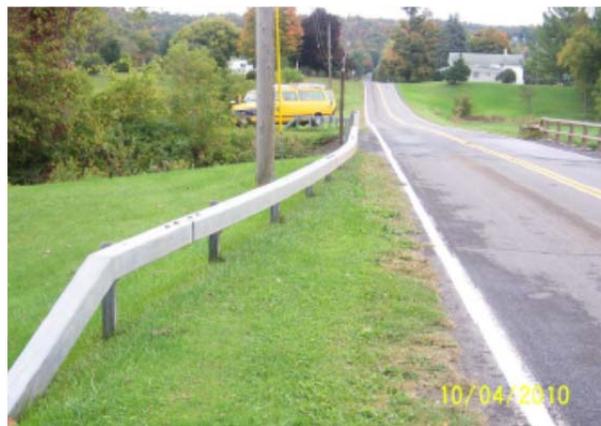
Figure 3-13: Narrowing of Usable Shoulders in the Bridge 3308970.

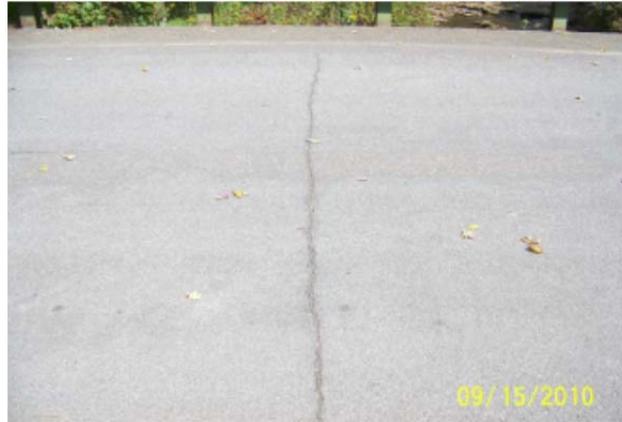
Figure 3-14: Crack in the Wearing Surface of the Bridge 3350660.

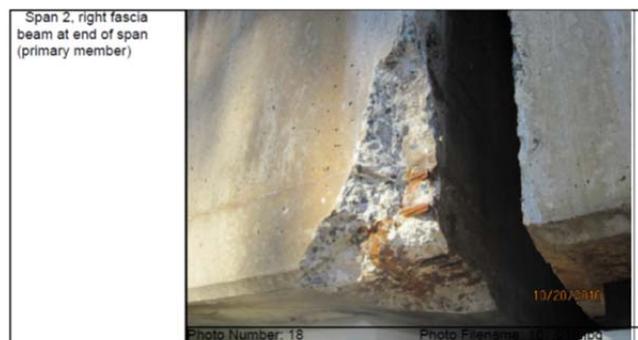
Figure 4-1: Example of a Very Good Photograph.

Figure 4-1 shows an example of a very good up-close photograph. The photograph clearly displays extent and severity of spalling at the end of a fascia girder. The photograph is clear, with good lighting, and is referenced in the accompanying note, which describes the condition shown in the photograph. Figure 4-2 shows another example of a very good photograph showing the elevation view of the fascia girder with vertical cracking clearly observable in the image. Figure 4-3 shows an example of a poor photograph. The photograph is blurry. It is very difficult to see the subject of the photo. Details of the bridge condition cannot be determined from the photograph, and the angle of the photograph makes it difficult to discern the point of interest. Each photograph in every report was assessed based on this simple rating scale to determine the quality of photographs in the inspection reports.

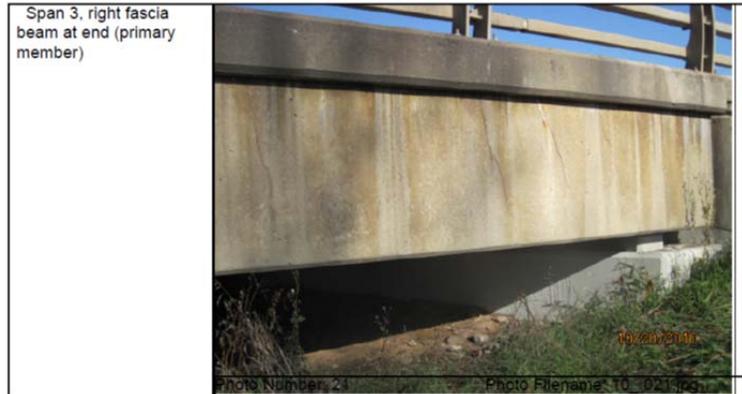
Figure 4-2: Example of a Very Good Photograph.

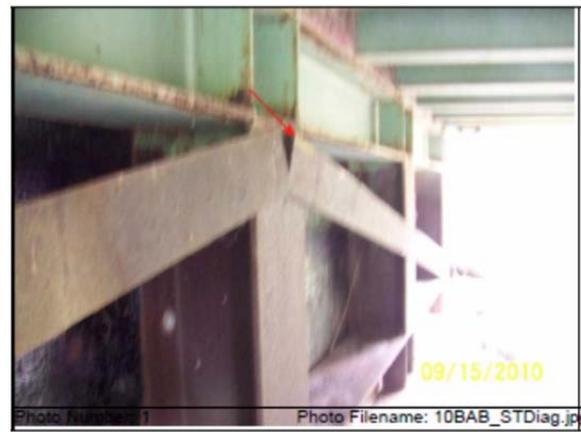
Figure 4-3: Example of a Poor Photograph.

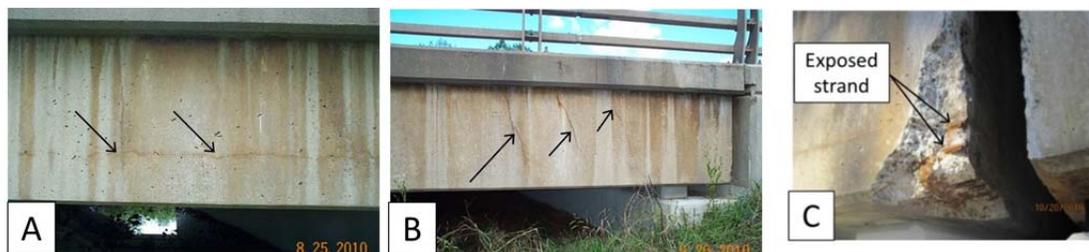
Figure 4-4: Three Damage Areas Assessed Using Notes and Photographs.

To analyze the consistency of the notes in the inspection reports for identifying specific damage modes, notes for the bridge 1026970 were assessed for three specific damage modes in the superstructure of the adjacent box girders. These include (i) a splitting crack along the fascia girder of span 1 shown in Figure 4-4(a), which runs along the length of the girder approximately 9 to 12 inches from the soffit, (ii) vertical/diagonal cracks in span 3 of the bridge, shown in Figure 4-4(b) and (iii) a large spall in the corner of the box girder, which has exposed 2-3 inches of the embedded strands, as shown in Figure 4-4(c). The identification of these common damage modes was assessed through the inspector's notes, photographs and flags, in cases where the inspectors identified a flagging need. For the longitudinal cracking in span 1, inspectors that reported a longitudinal crack in the primary member notes along some or all of beam 13, or span 1 right side, were counted as having reported this damage mode. For vertical cracking in the Span 3, inspectors that noted vertical cracks, vertical shrinkage cracks, hairline crack or shear cracks, etc., located in span 3 right side, were counted as having reported the damage. For the spalling at the corner of the fascia beam in the span 2 (Figure 4-4c), inspectors that noted spalling at this location with exposed strand or bar, or with rust staining, were counted as having recorded the damage mode. To assess the photographs, the photographs referenced in the notes were identified in the report.

The results of the assessment are shown in Table 4-8 below. As shown in the table, the concrete cracking in spans 1 and 3 were noted by more than half of the inspectors, with one inspector indicating that a yellow flag was warranted for the vertical cracking. For the spalling with exposed rebar or strand, only 15% (3/20) reported this damage mode with exposed strand; one inspector indicated that the condition required a yellow flag until the effect of the damage on the load carrying capacity could be evaluated. There were 6 inspectors who did not note any of the three damages in the notes section of the report. These data may illustrate some variation in the level of detail in the inspection reports, or differences in the perspectives of inspectors regarding the importance of these damage modes. It should be noted that two inspectors found that there was reason to issue a flag in response to one of these conditions. These flags were for different damage modes (spalling with exposed steel and vertical cracking in span 3) and were issued by different inspectors. This can be used for training inspectors about the importance of notes in inspection reports for conditions that don't warrant flag. It is observed from the pictures in Figure 4-4 that the cracks and damages are obvious and must have been seen by the inspectors. It seems likely that many inspectors didn't report these damages in their reports either because these damages were already mentioned in previous reports or didn't consider them affecting the safety of the bridge.

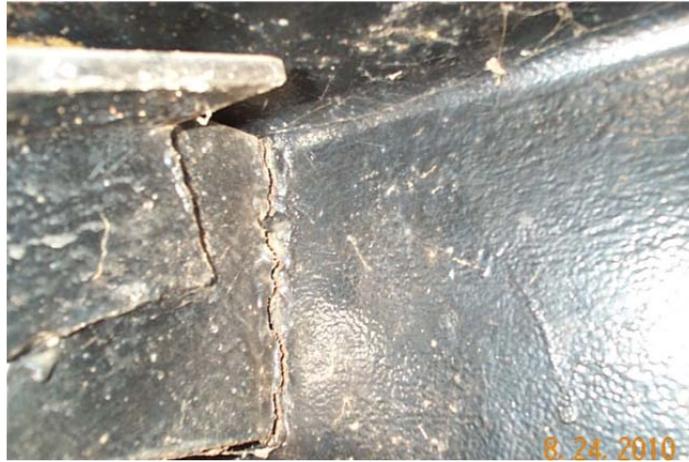
The results from bridge 3308970 were assessed to determine if the presence of a special emphasis area sketch affected whether or not the damage was detected. Of the eight teams that included a sketch, only three had reported the damage (38%), while for the group of twelve teams that did not include a sketch, seven reported the damage (58%). Therefore, these results show a lack of relationship between the inclusion of the sketch and the detection of the damage. In fact, a larger portion of the teams without the sketch reported the damage than those that included the sketch in the report. Similarly, conducting 100% hands-on inspection did not seem to affect the reporting of the damage. In fact, among the teams reporting 100% hands-on inspection, 9 teams reported the damage and other 9 didn't. Similarly, among the two teams that did not report 100% hands-on inspection, one reported the damage while the other one didn't.

Figure 4-6: Photograph of Cracked Diaphragm Bracing Connection.

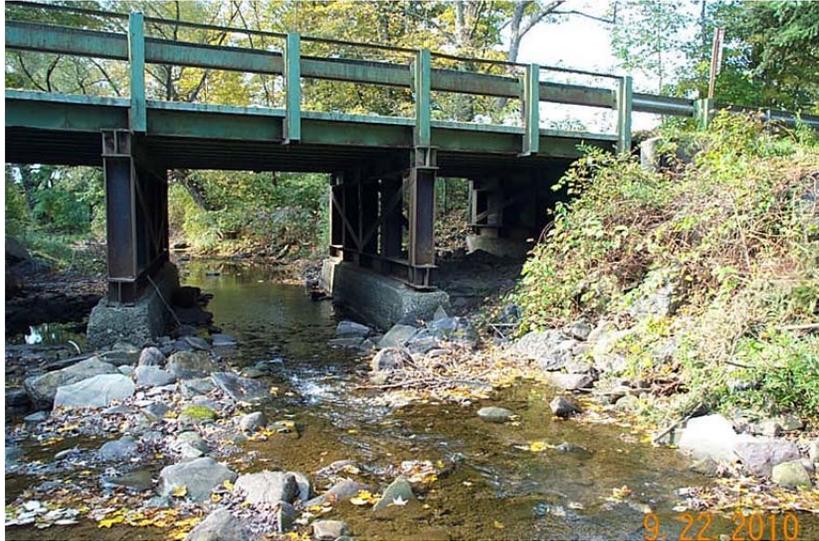
Figure 4-9: Elevation View of Bridge 3350660 Showing Footings Exposed to Scour.
